**DEPARTMENT OF TRANSPORTATION**

Contract #: 04-0120F4Cty: SF/ALA Rte: 80 PM: 13.2/13.9File #: 69.28**WELDING INSPECTION REPORT****Resident Engineer:**Siegenthaler, Peter**Address:** 333 Burma Road**City:** Oakland, CA 94607**Report No:** WIR-017720**Date Inspected:** 25-Oct-2010**Project Name:** SAS Superstructure**OSM Arrival Time:** 700**Prime Contractor:** American Bridge/Fluor Enterprises, a JV**OSM Departure Time:** 1900**Contractor:** Zhenhua Port Machinery Company, Ltd (ZPMC), Changxing Island **Location:** Shanghai, China**CWI Name:** Mr.Qiu Wen.**CWI Present:** Yes No**Inspected CWI report:** Yes No N/A**Rod Oven in Use:** Yes No N/A**Electrode to specification:** Yes No N/A**Weld Procedures Followed:** Yes No N/A**Qualified Welders:** Yes No N/A**Verified Joint Fit-up:** Yes No N/A**Approved Drawings:** Yes No N/A**Approved WPS:** Yes No N/A**Delayed / Cancelled:** Yes No N/A**Bridge No:** 34-0006**Component:** Tower and Orthotropic Box Girder (OBG)**Summary of Items Observed:**

## WELDING INSPECTION REPORT

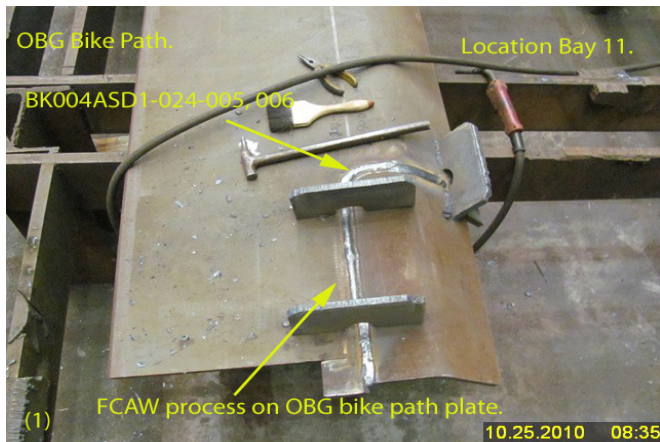
This QA Inspector observed ZPMC qualified welding personnel identified as 040704, Perform Flux Core Arc Welding (FCAW) on OBG bike path plate. Joint identified as BK4ASD1-024-005, 006. ZPMC CWI Identified as Yu Dong Ping. The welding parameters as measured using QC's calibrated instrument appeared to be in general compliance with WPS-B-T-2231-B-U2-F. For more information see below attached picture number 1.

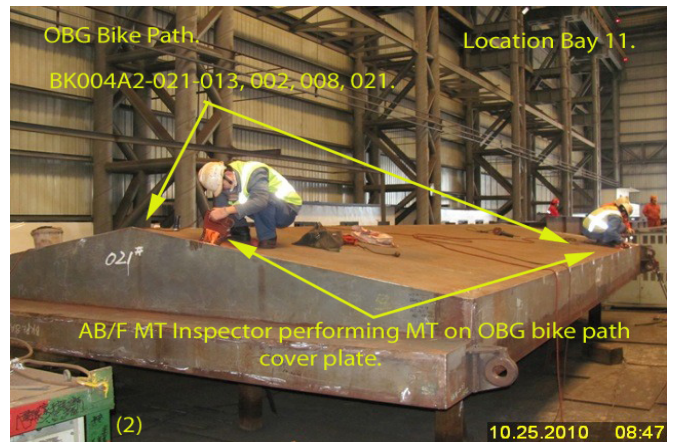
This QA Inspector observed AB/F Magnetic Particle Testing Inspector, performed MT on OBG Bike path cover plate. Joint identified as BK004A2-021-013, 002, 008, 021. For more information see below attached picture number 2.
